# SITE ASSESSMENT REPORT FOR THE RIVER BEND SITE DETROIT, WAYNE COUNTY, MICHIGAN

#### WESTON SOLUTIONS, INC.

Date Prepared: February 23, 2011

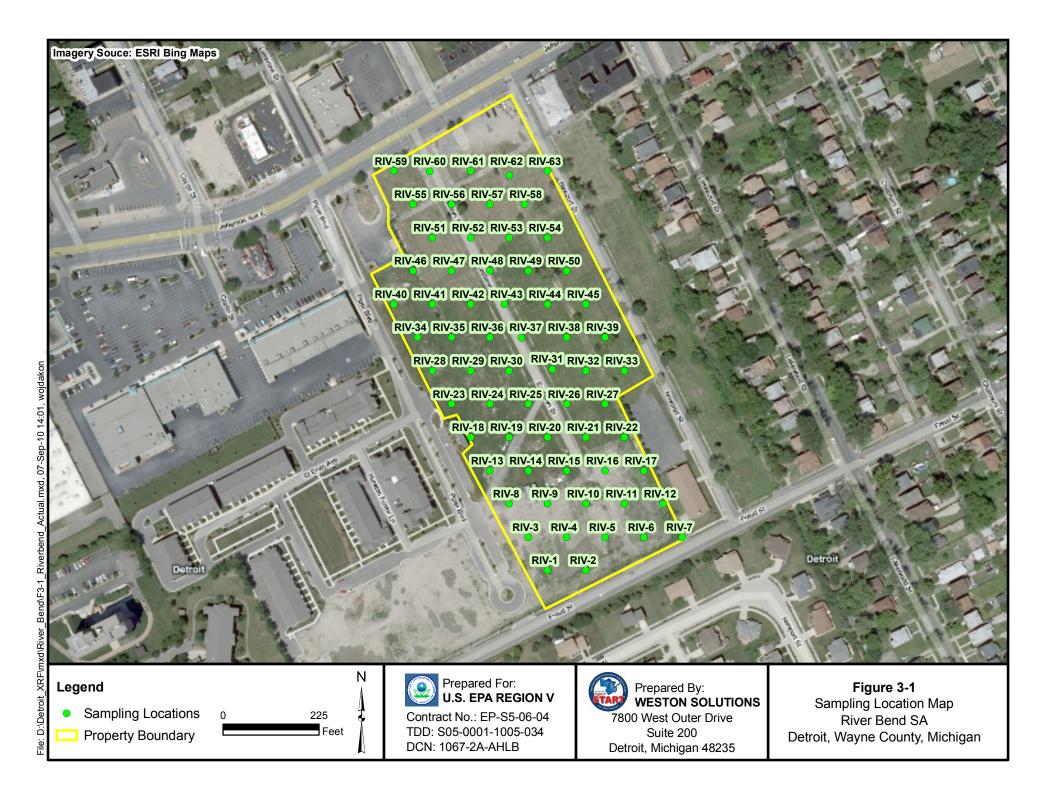
and flagged each location for screening. Figure 3-1 shows the screening locations, which are

throughout the Site using an Innov-X XRF analyzer. **Figure 3-1** shows the screening locations.

identify the XRF screening and potential sampling locations. The VSP software identified 67

screening locations to locate a hotspot with a 50-foot-radius with a 95 percent probability.

Locations RIV-64 through RIV-67 were eliminated from the screening because of concrete

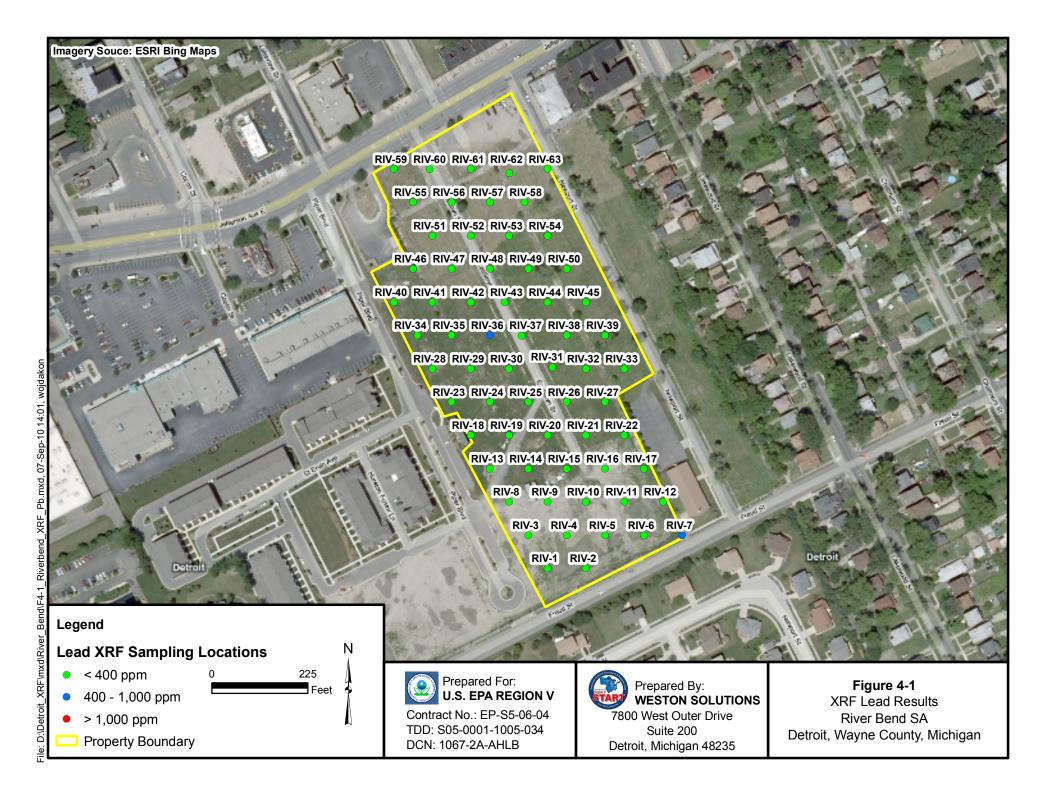
**Table 4-1** summarizes the XRF results for the 63 XRF screening locations, and **Figure 4-1**

The XRF lead screening results ranged from 14 to 703 parts per million (ppm), with the highest

contact risk. XRF screening results for (2) two locations exceeded the lead value of 400 ppm

(RIV-7 and RIV-36) and (2) two locations exceeded the arsenic value of 7.6 ppm (RIV-7 and

Based on the XRF readings, three locations exceeded the MDNRE Part 201 - Residential and Commercial I Direct Contact Criteria for either lead or arsenic or both. The XRF results also were compared to the State of Michigan Default Background levels, and cadmium, copper, iron, lead, manganese, nickel, silver, and zinc results exceeded the background levels but were below the MDNRE Part 201 Residential and Commercial I Direct Contact Criteria. The XRF readings

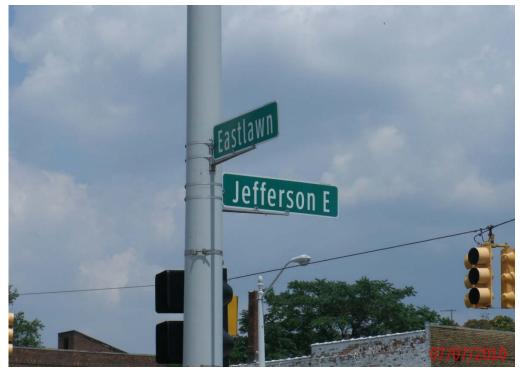
Photograph No.: 1

**Direction:** North **Photographer:** M. Beer **Subject:** Site located at the southwest corner of Eastlawn Street and East Jefferson Avenue

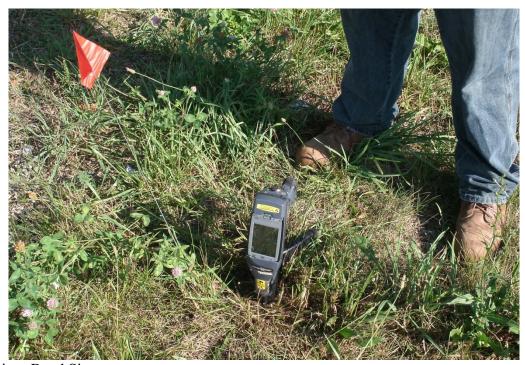
Site: River Bend Site **Photograph No.:** 6 **Direction:** Down

Subject: XRF screening of surface soils
